Thermographie-Forum 2021
Eugendorf, A

Frühzeitige Erkennung von Materialschädigungen aufgrund mechanischer Belastung mittels Thermographie

Dr. Günther Mayr, Lukas Gahleitner & Jürgen Gruber

Research Group of Thermography & NDT (www.thermo-ndt.com)
University of Applied Sciences Upper Austria, School of Engineering, Wels , Austria

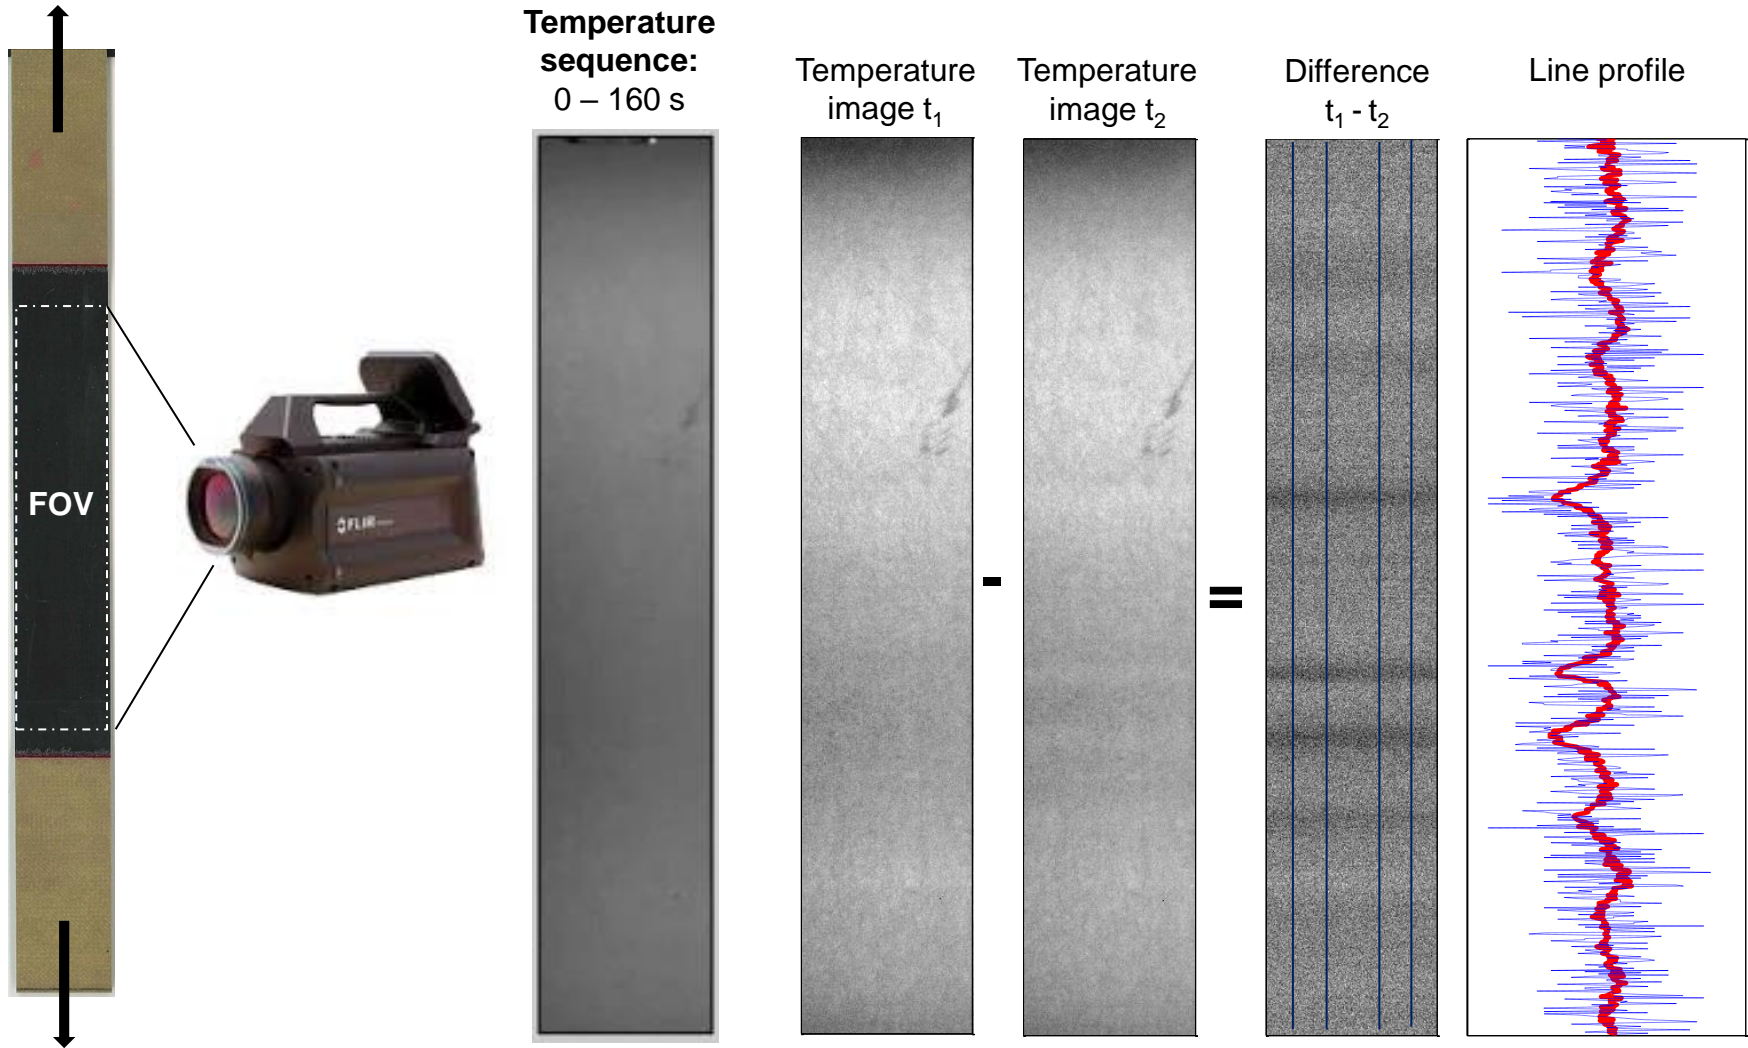
Type I – Transverse matrix cracking

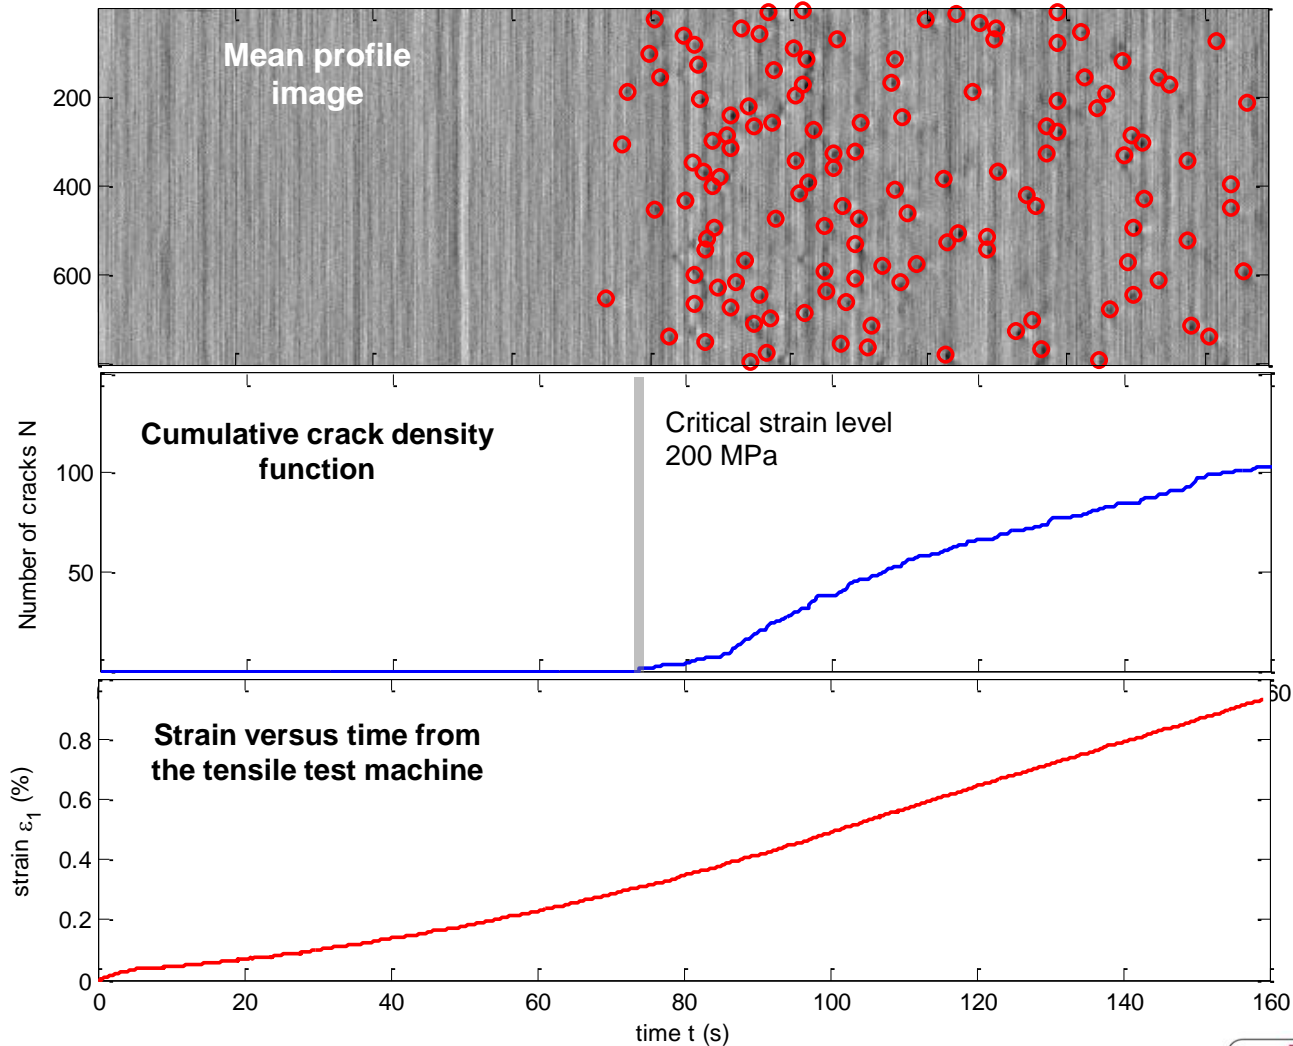
Type I – Transverse matrix cracking

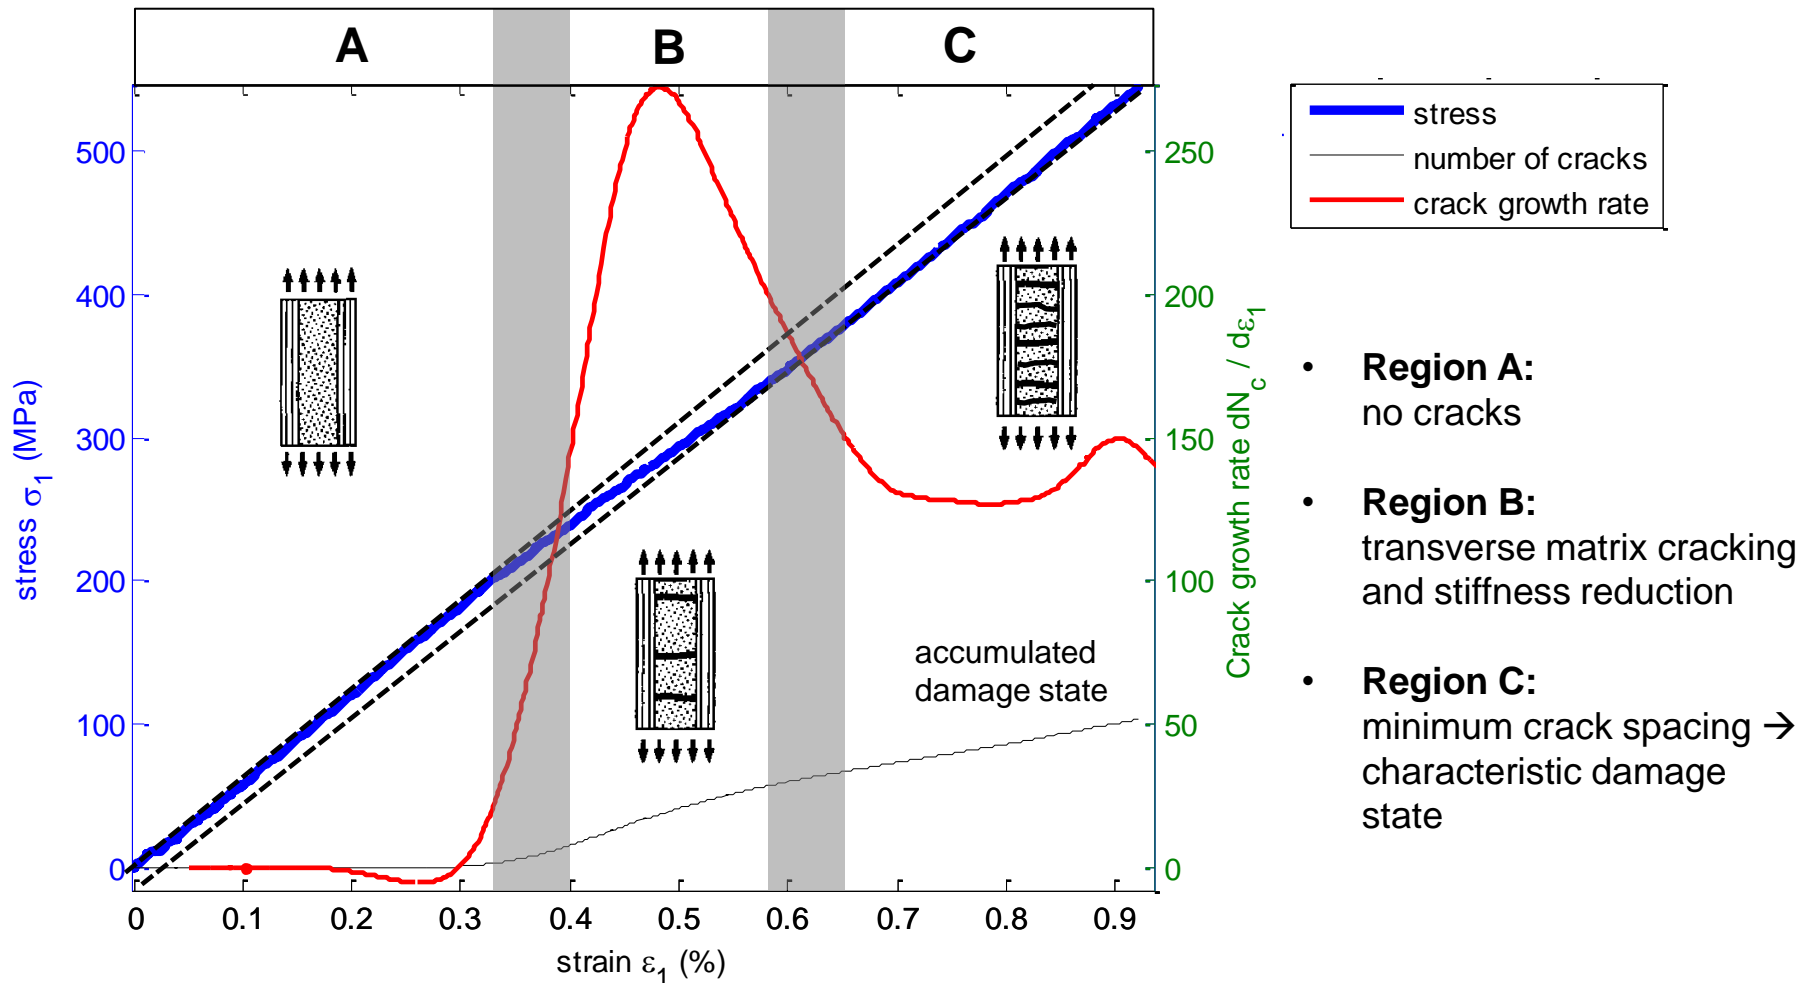
Type I – Transverse matrix cracking

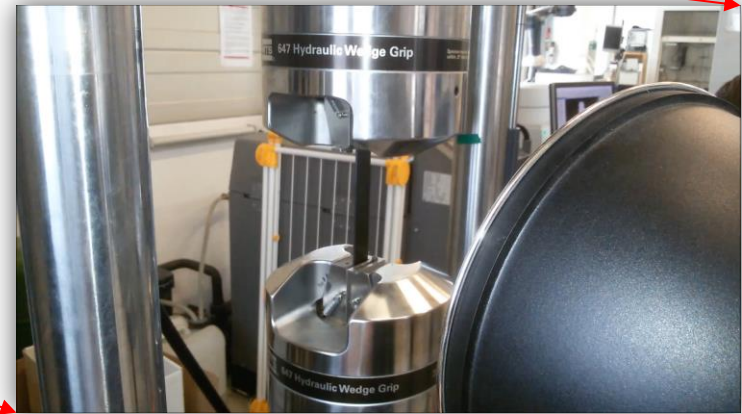
Experimental setup – Pulsed thermography

Servo-hydraulic tensile test machine

MTS 370.10 Landmark ± 100 kN

Frequency = 10 Hz

Maximum stress: $\sigma_{\max} = 500$ MPa

Minimum stress: $\sigma_{\min} = 50$ MPa

Pulsed thermography setup

IRCAM Equus 81k M Pro

Flash light: Bläsing G6000z

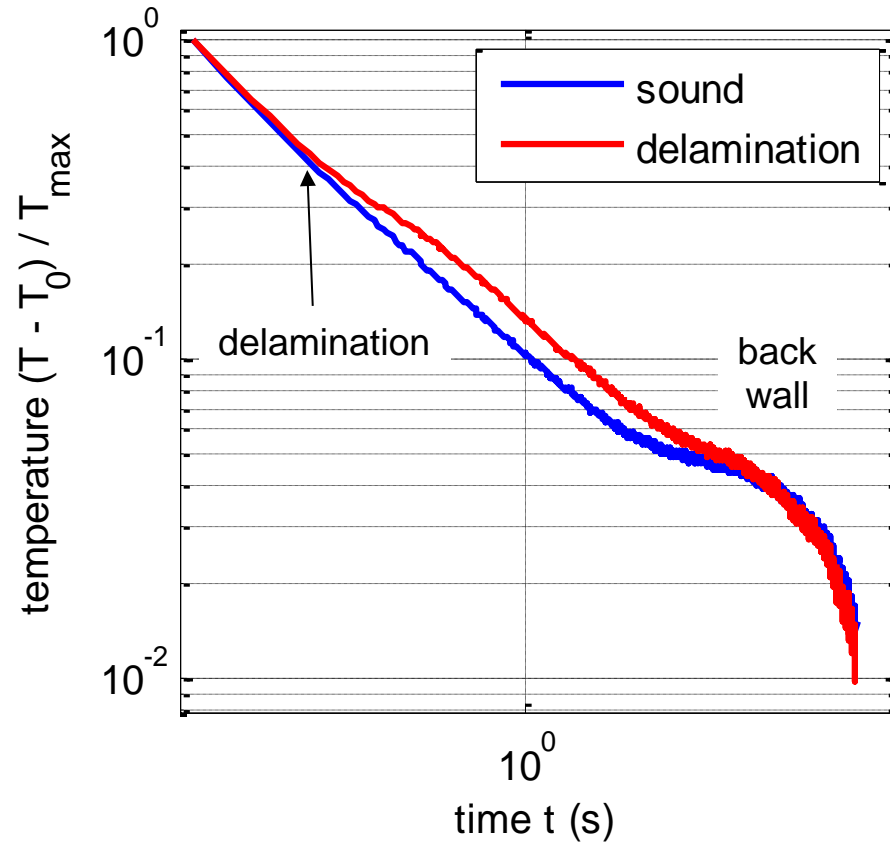
Pulsed thermography – temperature evolution

thermogram after
10k cycles

heating of the
pneumatic cylinder

sound region

free edge
delamination

log – log plot

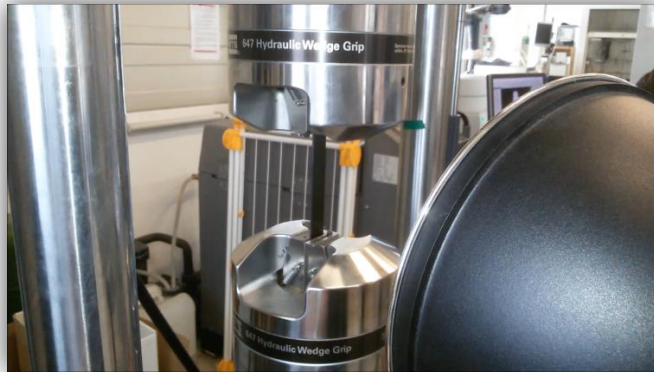
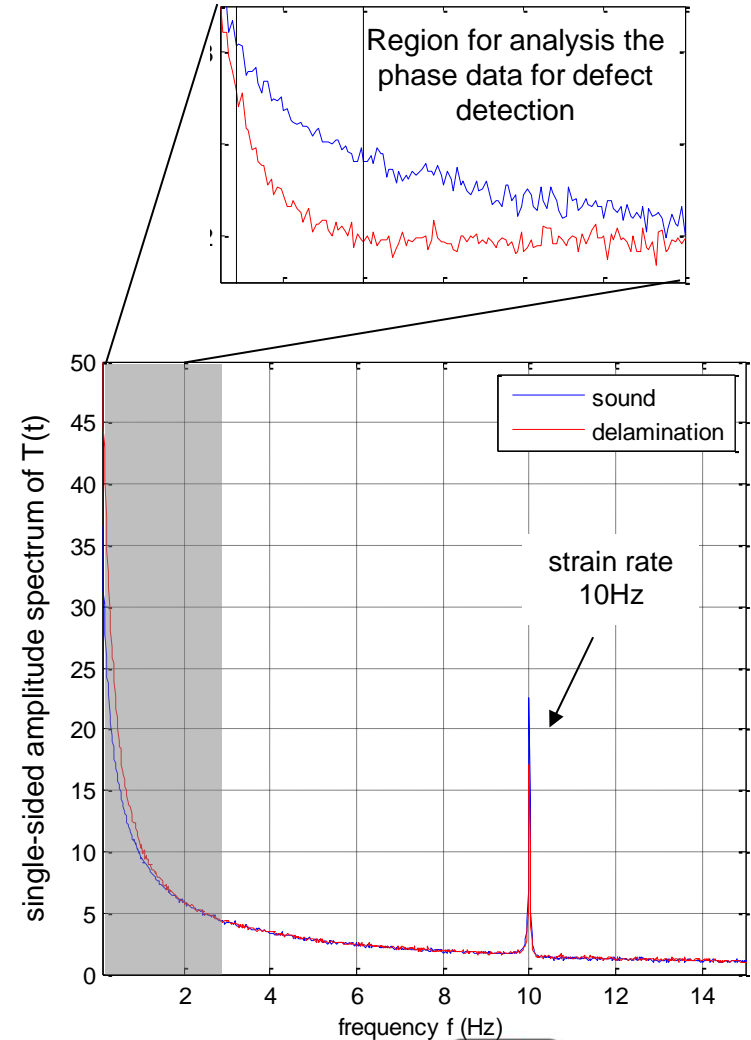
In-situ PPT with separation of the strain rate

FFT

- The **initiation** and **progression** of **matrix cracking** in a carbon/epoxy laminate can be detected **in-situ** with **passive thermography**
- The detected **matrix crack density** function explain the measured **stiffness reduction** due to tensile loading
- The **frequency separation** in PPT allows the **in-situ** identification of the **delamination size** without any disturbance of the mechanical loading and deformation
- The **Virtual Wave Concept** enables a **3D imaging** of the defect with increasing fatigue

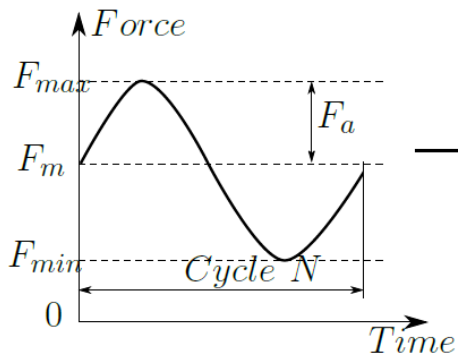
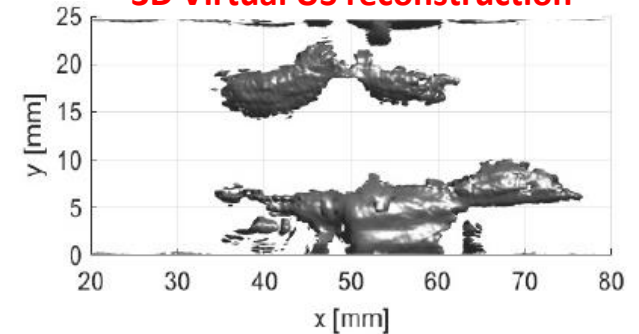
Damage Imaging

defined loading

material parameter estimation

active IRT measurement

3D reconstruction of internal defects

visible surface
defect lines

Virtual Wave Field

3D Virtual US reconstruction

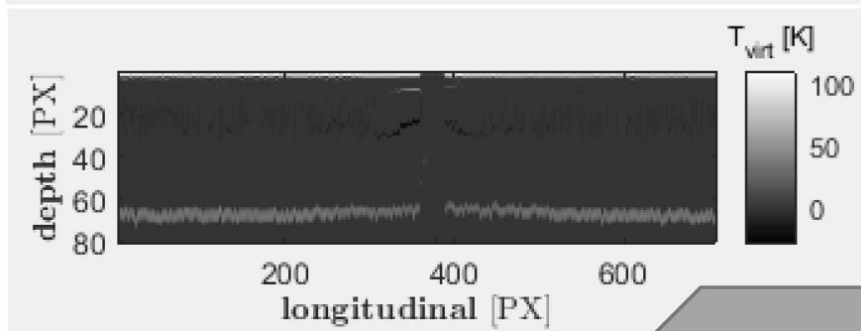
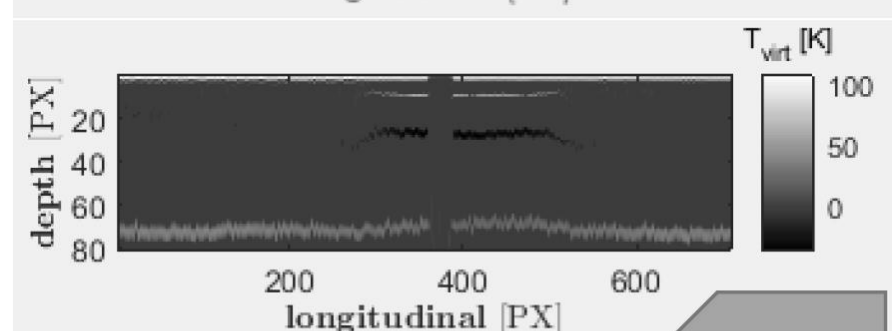
Virtual Wave Concept for Image Reconstruction

@12k cycles

@32k cycles
